TECHNICAL REPORT

NO. 12776

WINTER TESTING OF VEHICLE
EXHAUST DUST EJECTION SYSTEM, RUBBER
TIRE HUBS, AND PERSONNEL HEATER SYSTEM
ON THE M60 A3 TANK

JUNE 1982

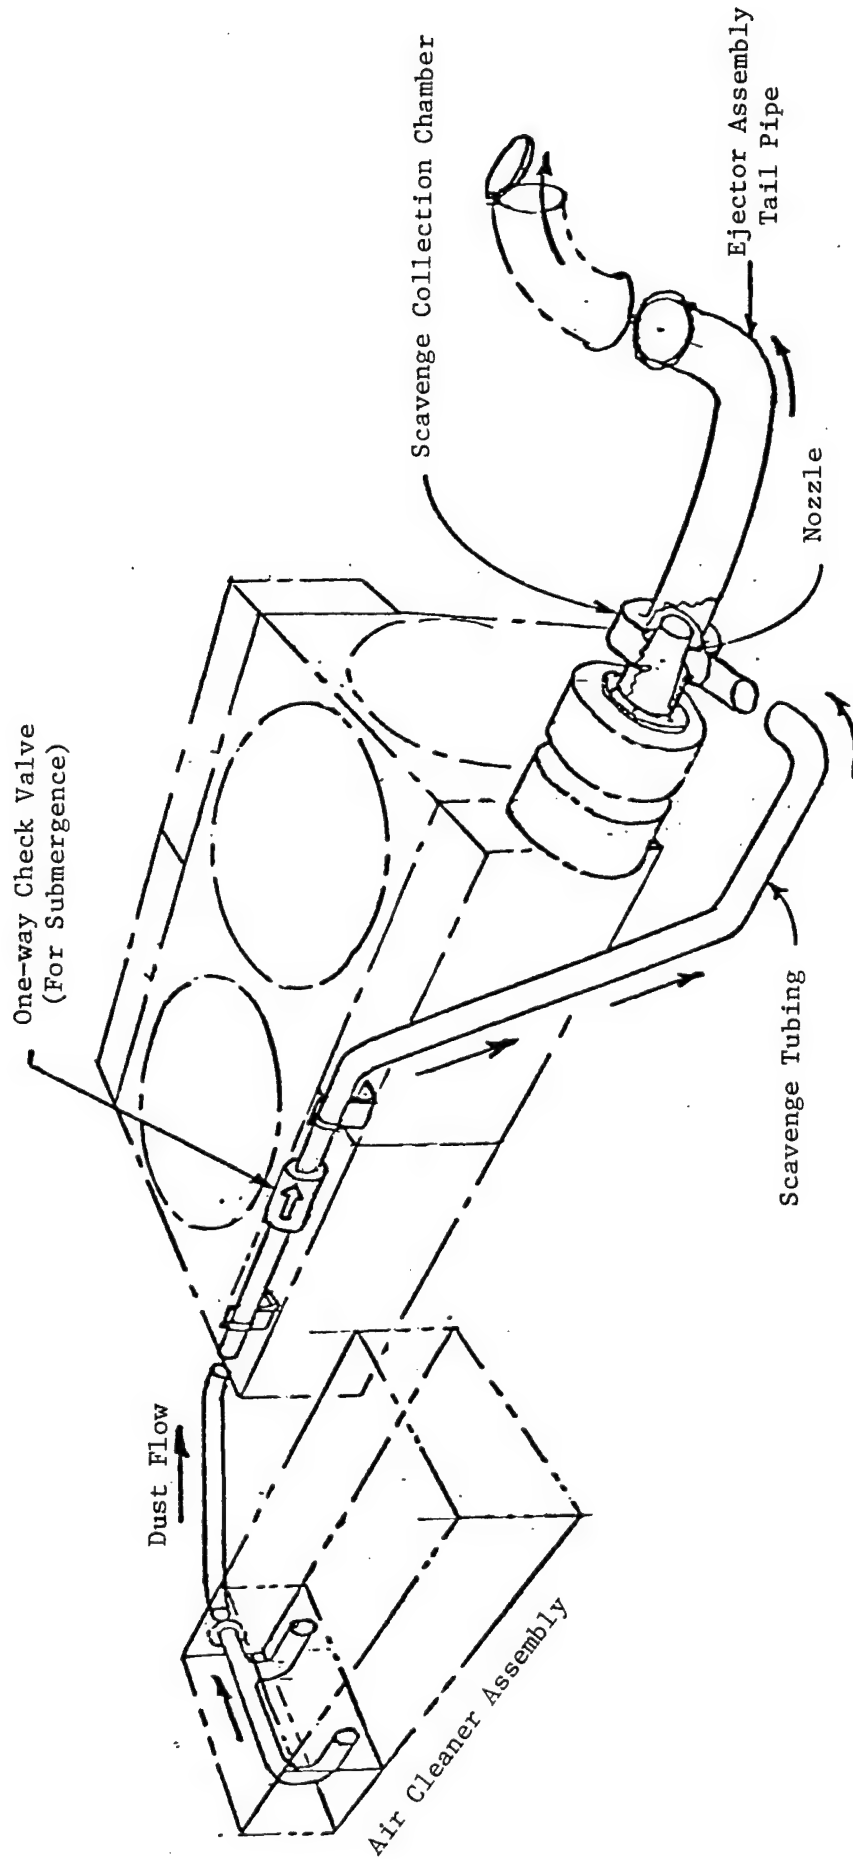
Figure 7. Diagram of VEDES System

Water accumulation in the scavenge tube occurs as a result of flow reversal. When the vehicle is parked outside in cold temperatures, the VEDES check valve freezes shut. The frozen valve must be broken free before the vehicle can be operated. Monitoring the differential pressure across the tube can alert the driver of blockages resulting from either a frozen check valve or accumulation of snow in the tube. (DiDonato, 1982).

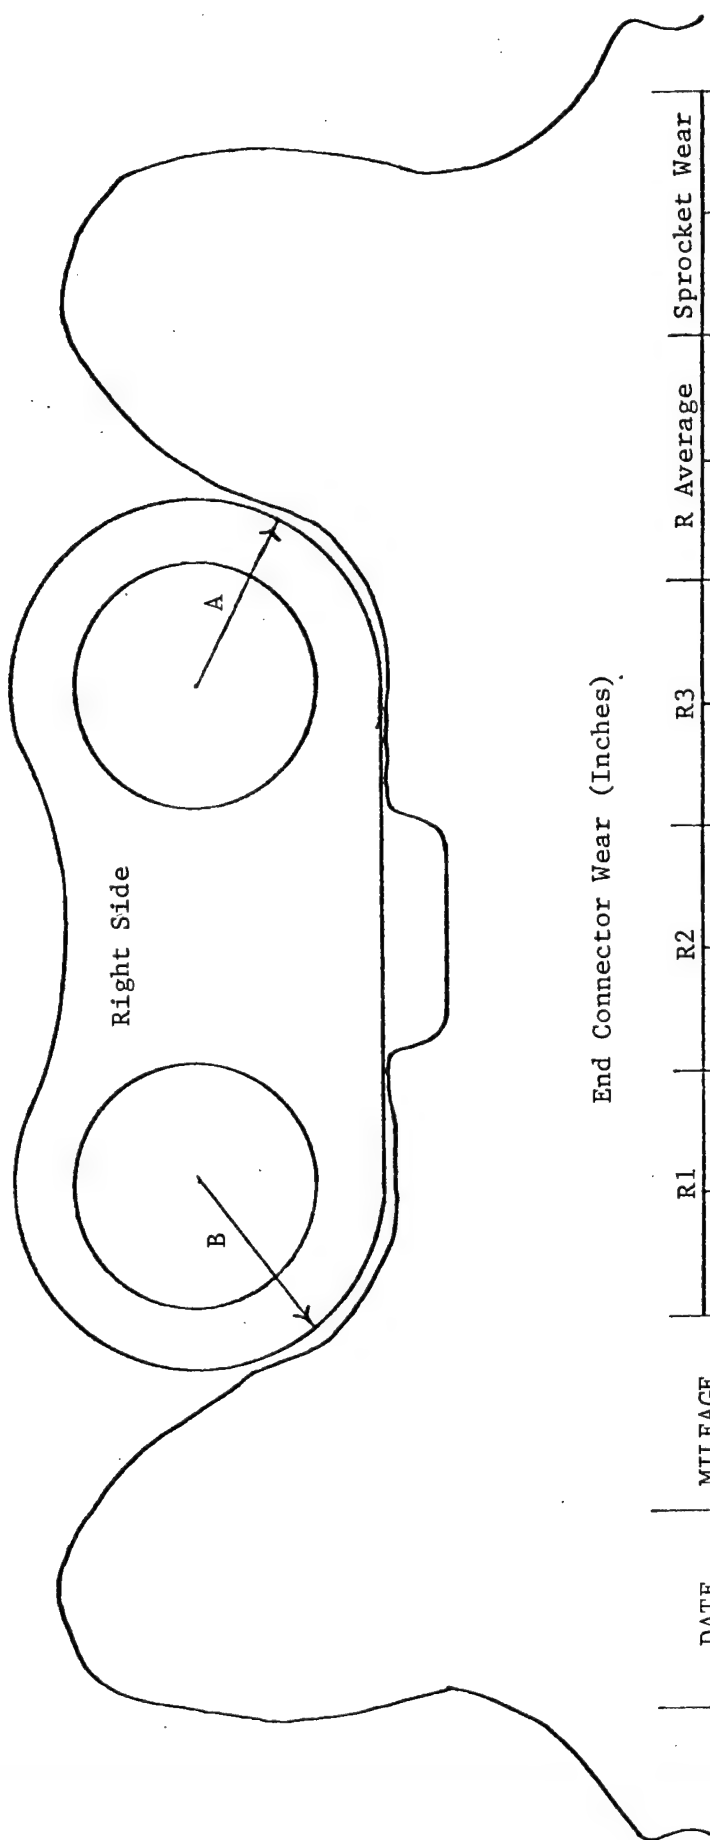
M60 Track End Connector and Sprocket Wear Data
Snow Testing of Rubber Tire Hubs

it was noted that there was a mismatch between the RTH sprockets and the track end connectors. This mismatch caused wear to the sprocket teeth and end connectors as seen in Appendix A. Appendix A shows wear to three selected end connectors on both sides of the track as well as the wear to the RTH sprockets.

DATE	MILEAGE	R1		R2		R3		R Average		Sprocket Wear	
		A	B	A	B	A	B	A	B	A	B
03/09/82	2138.6	.429	.425	.480	.400	.452	.445	.454	.423	.384	.329
03/12/82	2186.2	.426	.398	.460	.352	.479	.409	.455	.386	.387	.308
03/17/82	2248.9	.422	.396	.453	.370	.425	.375	.433	.380	.374	.325
03/18/82	2301.0	.455	.410	.462	.353	.424	.374	.447	.379	.380	.317
03/22/82	2361.9	.423	.397	.454	.341	.476	.418	.451	.385	.373	.328

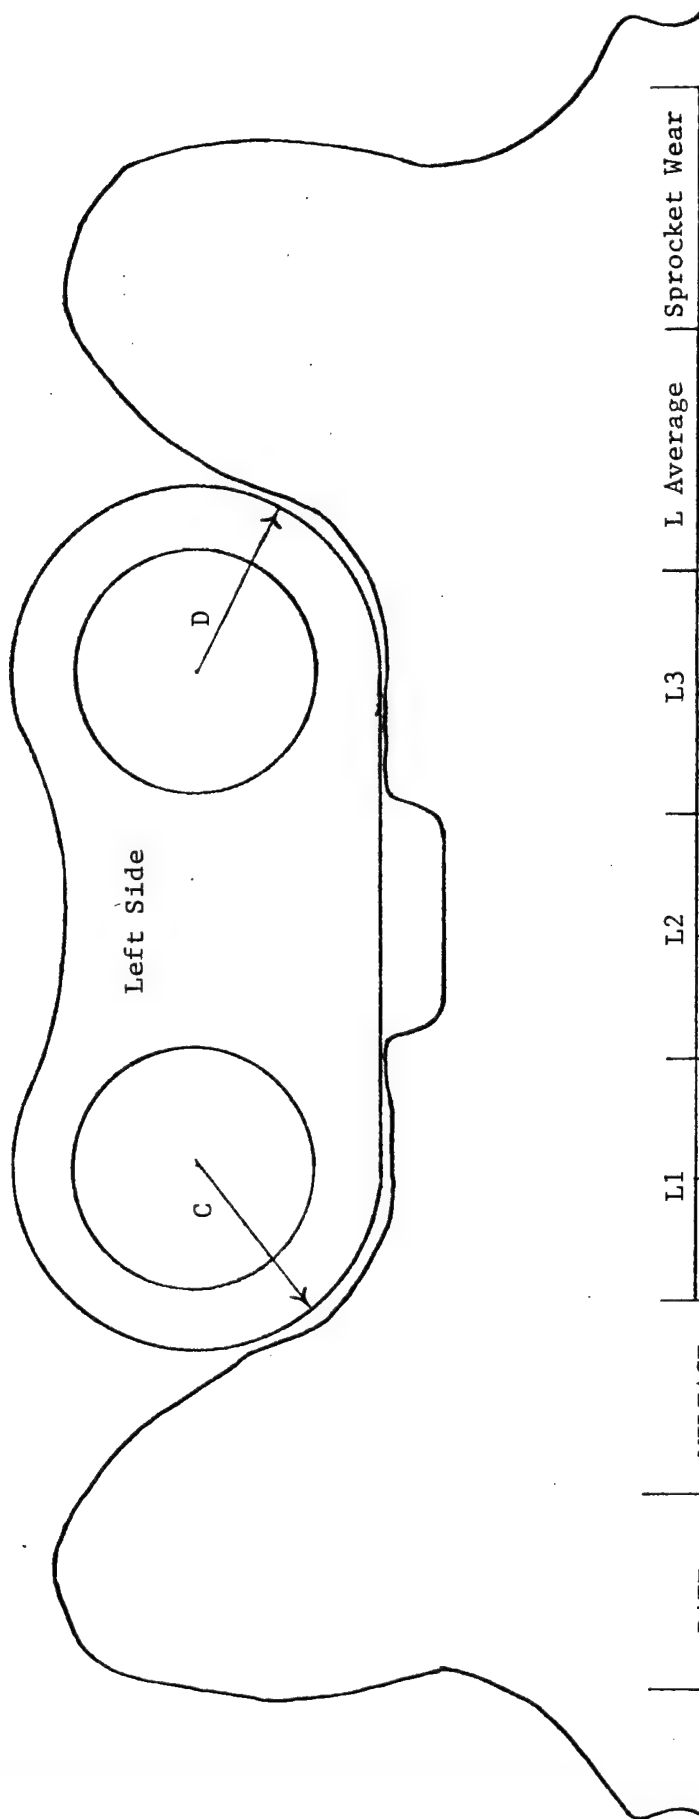
M60 Track End Connector and Sprocket Wear Data
Snow Testing of Rubber Tire Hubs

DATE	MILEAGE	L1		L2		L3		L Average		Sprocket Wear	
		C	D	C	D	C	D	C	D	C	D
03/09/82	2138.6	.440	.438	.462	.401	.462	.473	.471	.437	.460	.328
03/12/82	2186.2	.472	.412	.450	.371	.418	.459	.447	.414	.350	.335
03/17/82	2248.9	.468	.406	.453	.340	.421	.453	.447	.400	.352	.317
03/18/82	2301.0	.454	.398	.433	.367	.411	.433	.433	.399	.358	.326
03/22/82	2361.9	.456	.403	.436	.439	.402	.439	.431	.427	.359	.329
